Manhole Inspection Summary

Manhole # S41C__057MH

Inspection ☐ Is Incomplete Rating: **3) Fair**

Location Address: **s. central ave**

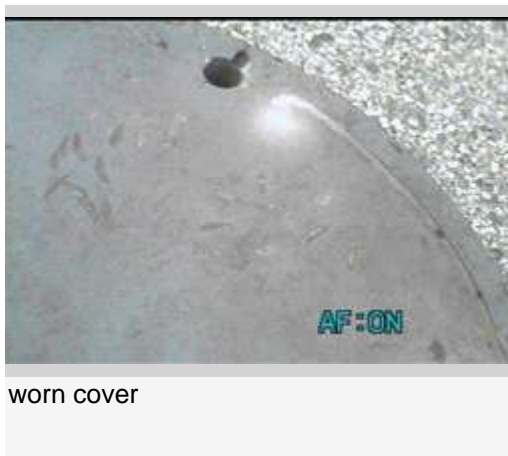
Miscellaneous

Type: **Sanitary** Condition: **Worn** Cover Material: **Cast Iron**

worn cover

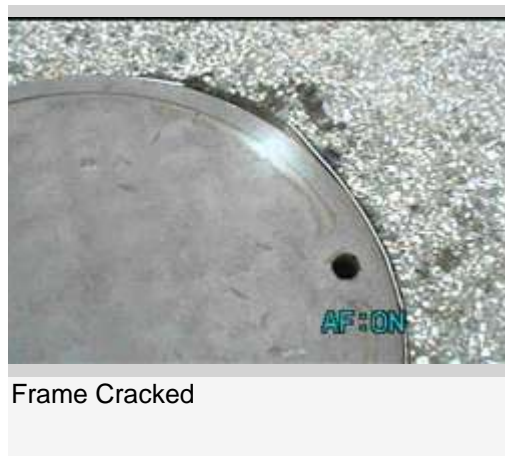
Defect 3

Frame Offset: **0** (in.) Condition: ☐ Sound ☒ **Cracked** ☐ Leaks

Frame Cracked

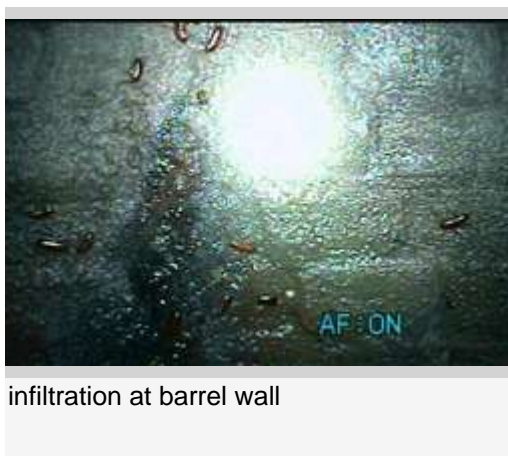
Defect 2

Infiltration: ☐ None ☐ Joint ☐ Cracks ☐ Mortar ☐ Roots ☒ **Wall**

infiltration at barrel wall

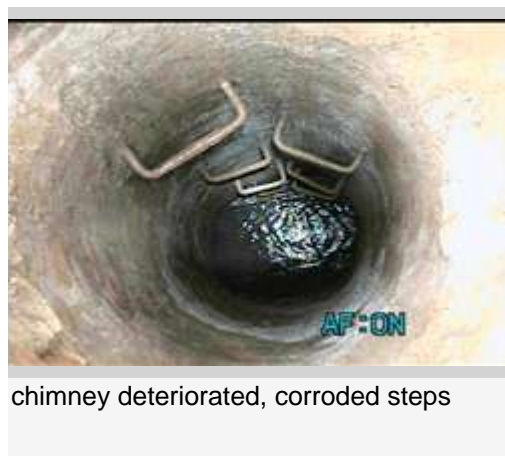
Defect 1

Condition: ☐ Sound ☐ Cracked ☐ Root Intrusion ☐ Loose Brick ☒ **Deteriorated**

Steps Count: **7** Missing: **0** ☒ **Corroded**

chimney deteriorated, corroded steps

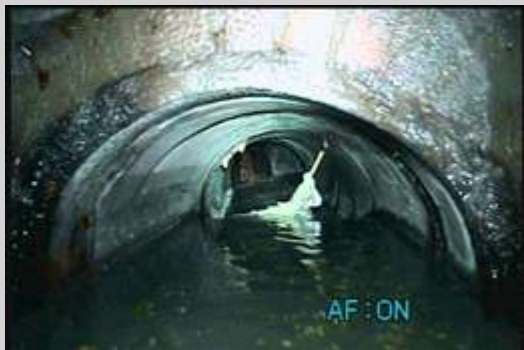
12 O'Clock Outflow

21 in. Circular Gravity Sewer
Pipe Out @ 12 O'Clock

Deposits: ☐ None ☐ Mud ☐ Sludge ☒ **Debris** ☐ Grease

Silt Depth: 3 (in.) Deposits Extent: **Light**
